Existing Conditions Report & Pool Study

Veteran's Memorial Aquatic Center | 360 Burr W Jones Circle, Evansville, Wisconsin 53536

City of Evansville

12 September 2017

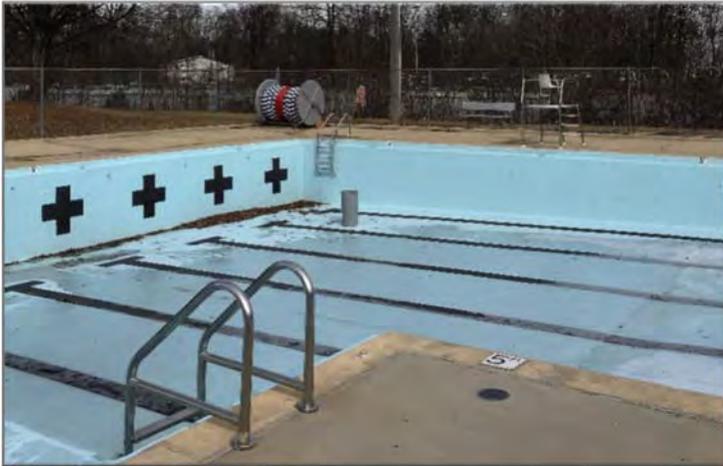
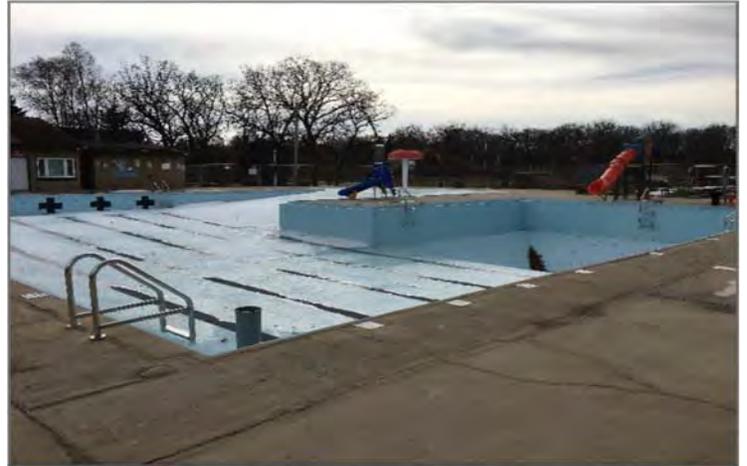
The Evansville Pool has a 25-meter, 6-lane lap area with an offset diving well. The original concrete structure is relatively sound and can remain for another 10 to 15 years with proper maintenance.

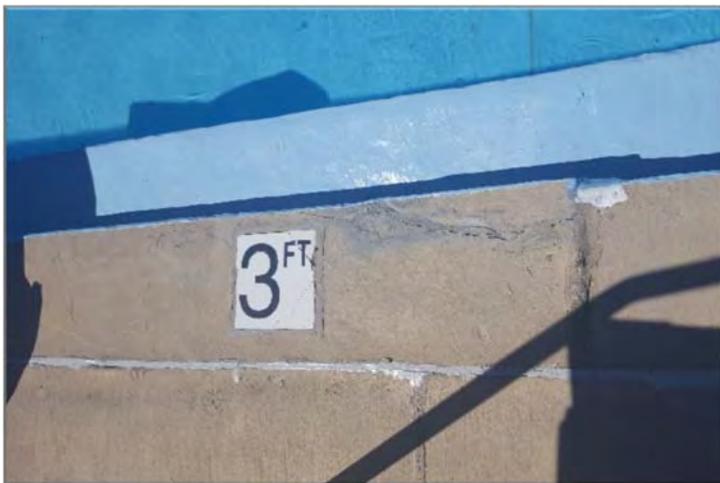
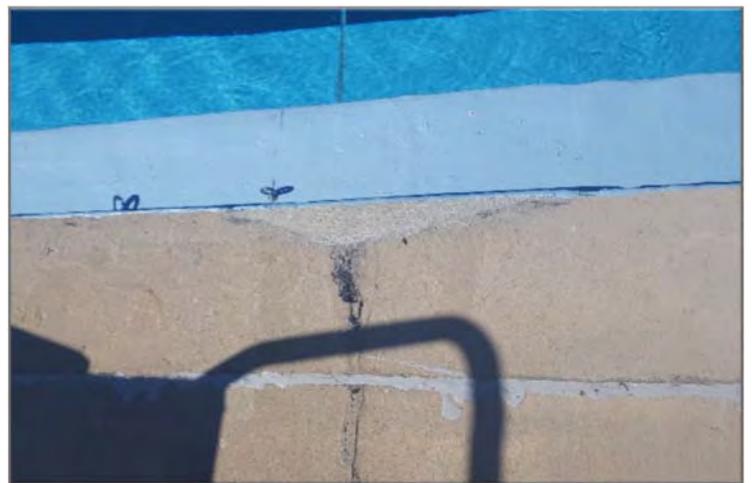
The top of the pool wall and gutter exhibit some deterioration. This should be monitored for future repairs (see photos below). The interior finish of the pool is paint. A new coat was installed this past spring after several repairs of concrete cracks and expansion joints. Repairs of this type will be required more frequently as the pool ages.

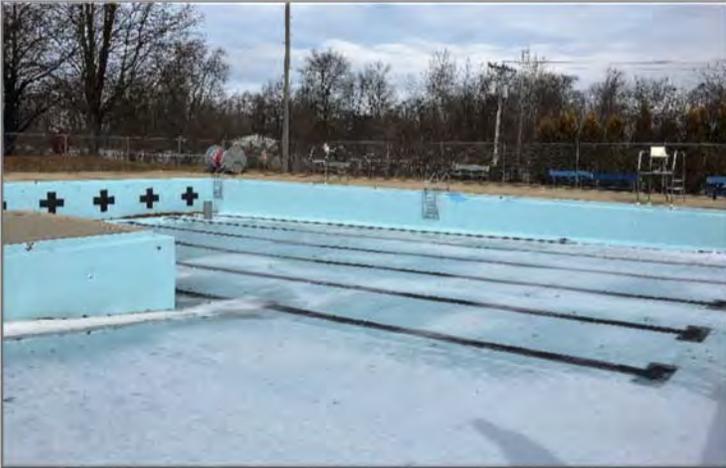
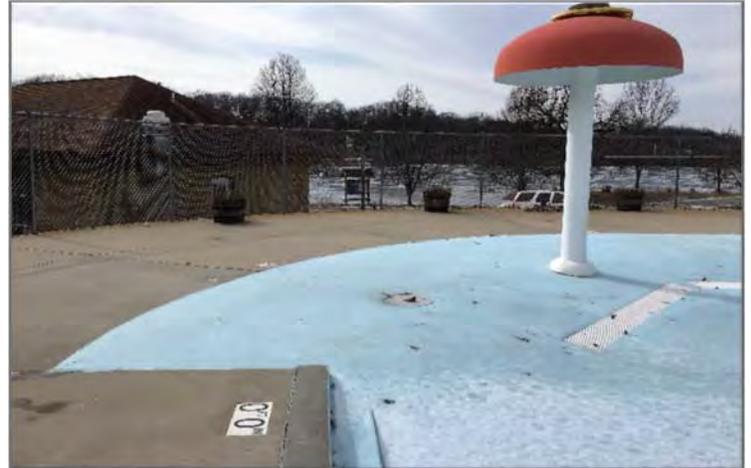
About 12 years ago a zero-depth area was added on the west side of the shallow end of the pool. This included a kiddie slide and raindrop water feature. The adjoining concrete deck was also replaced. It is likely that new pool piping was installed at the addition while the existing pool piping remained in place.

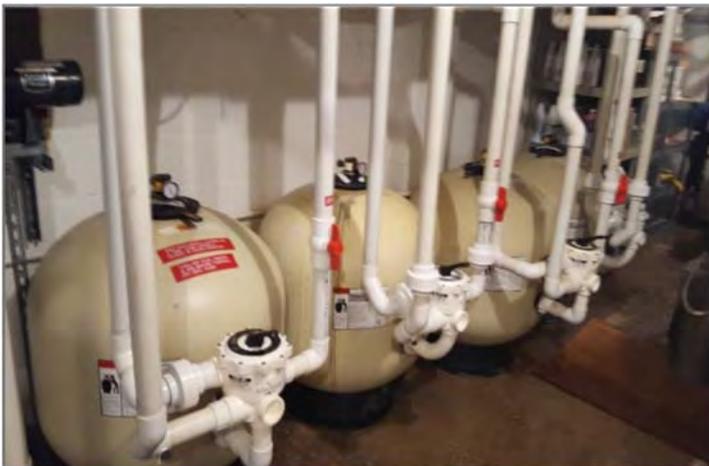
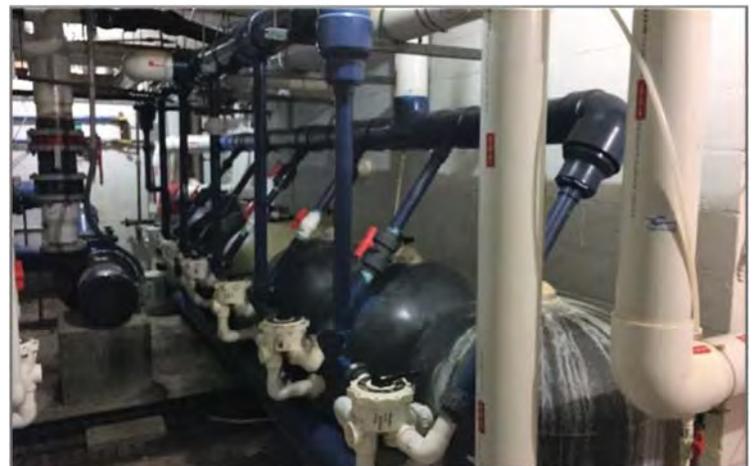
The original filtration system, before the zero-depth area was added, consisted of six (6), 36" diameter Pac-Fab Hi-rate sand filters. When the zero-depth area was constructed four additional 36" filters, now manufactured by Pentair, were installed. Last year one of the original Pac-Fab filters failed and was replaced with a Pentair filter. The remaining five (5) Pac-Fab filters are in fair to poor condition and could also fail at any time.

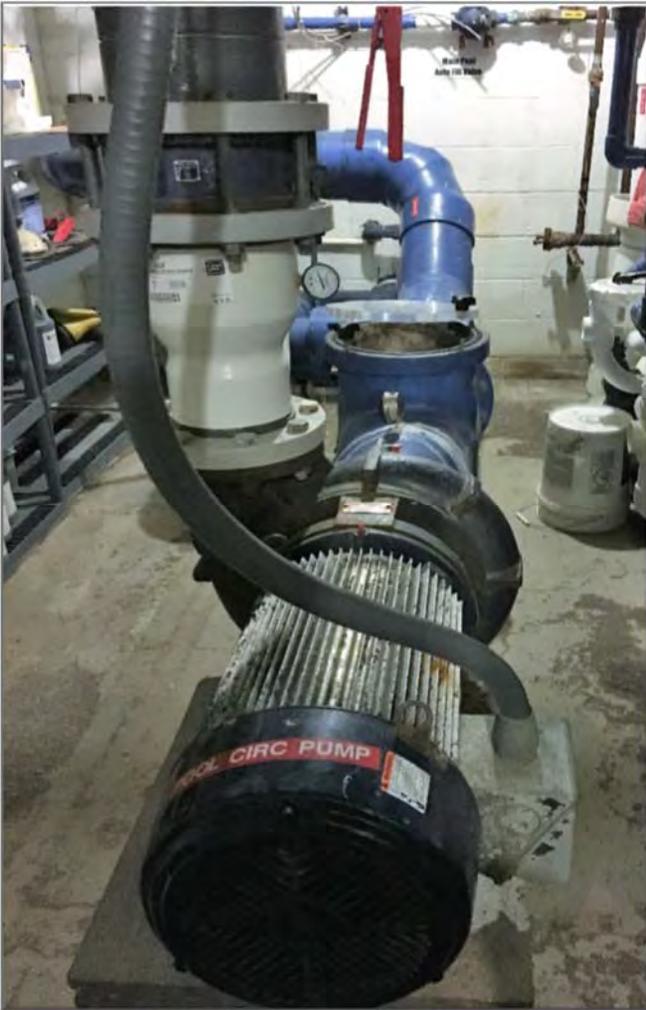
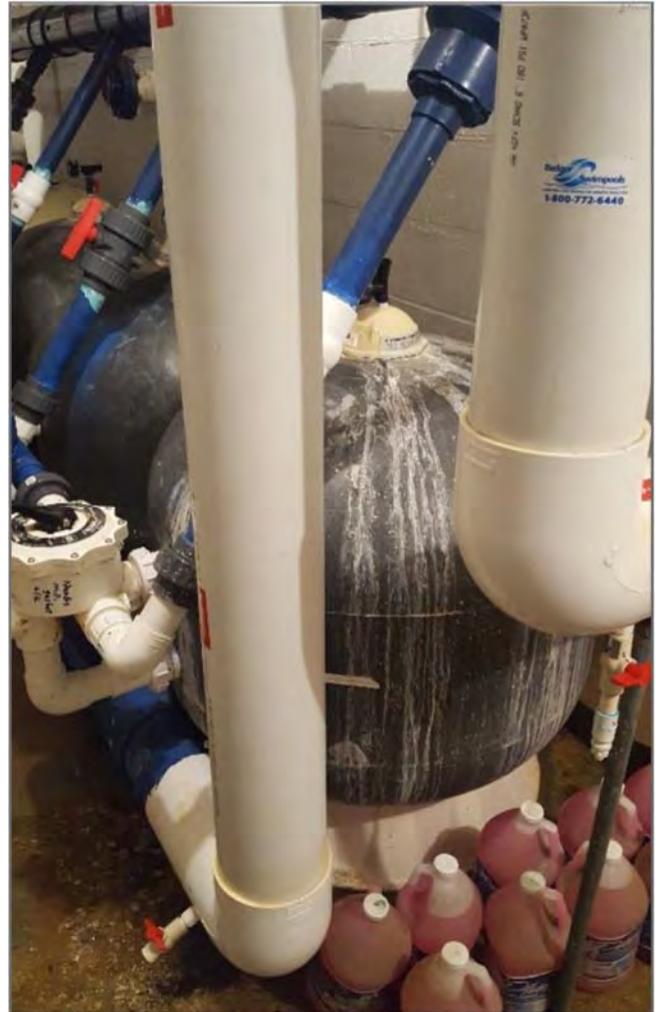
The filtration pump and motor is an Aurora model #341-BF. It is rated at 1,030 G.P.M @ 70' total dynamic head. Due to the number of filters, there is a concern as to whether this pump is actually capable of operating at 1,030 G.P.M. even when the filters are clean. It is highly likely that the flow rates of the filters do not meet current code due to the number of filters and their arrangement. We recommend this be monitored and verified if this is actually the case. With flow rates naturally reduced when filters are dirty, this is even a greater concern. This condition may require backwashing more frequently and add to the cost of chemicals, heating, and other costly conditions. Otherwise, this pump is in good condition.

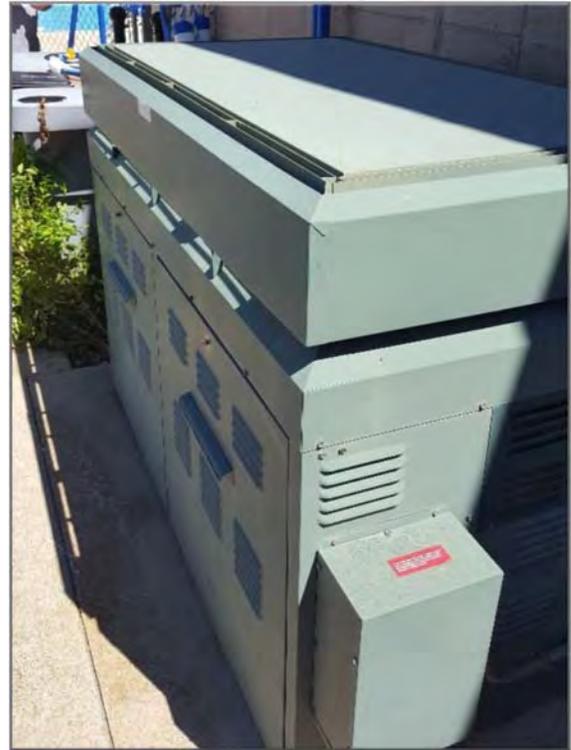
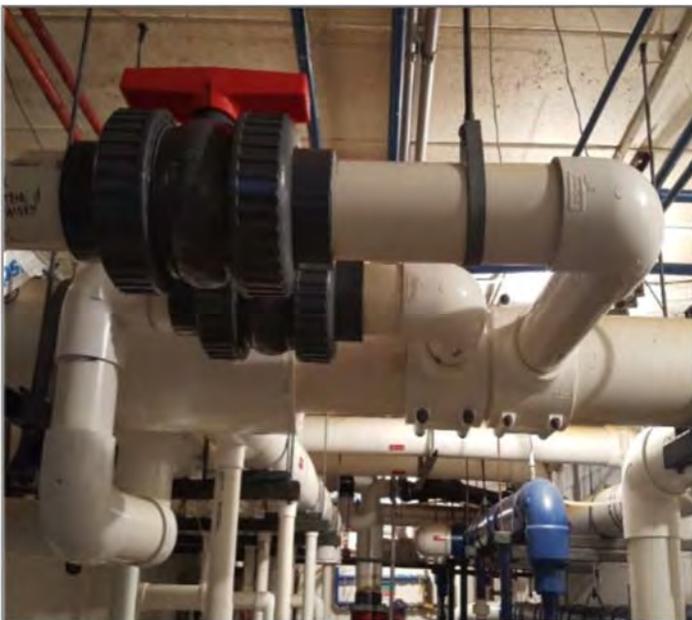
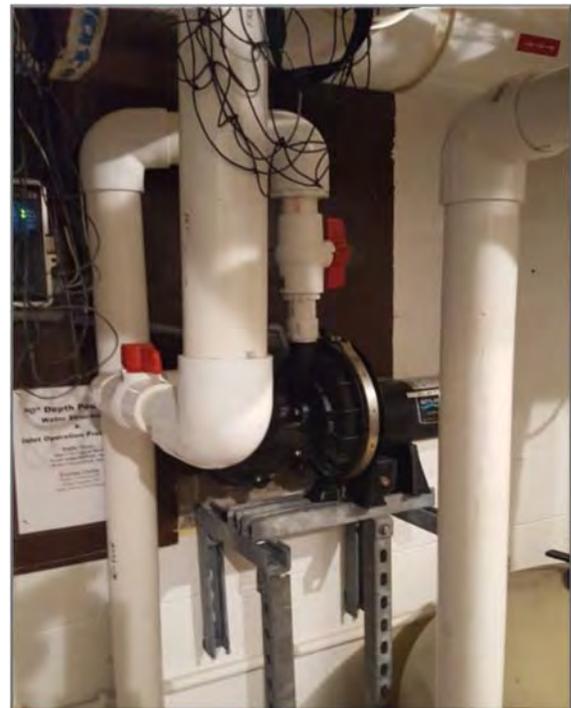
The pool water heater is manufactured by Raypak and has 1,035,000 B.T.U. input capacity. The heater, which operates on propane gas, is located outdoors on the west side of the bathhouse. Although the heater is an outdoor model, being exposed to the elements will shorten its life expectancy by several years when compared to an indoor model. With that said, this heater appears to be in fair condition (see photo to right).

The pool is also heated by solar panels located on the roof of the bathhouse. There is a small circulation pump as part of this system. The influent and effluent pipes that supply water to and from the panels were installed adjacent to each other, which may decrease the effectiveness of the system. It would have been more effective to have located the effluent pipe farther downstream from the influent pipe (see photos below).

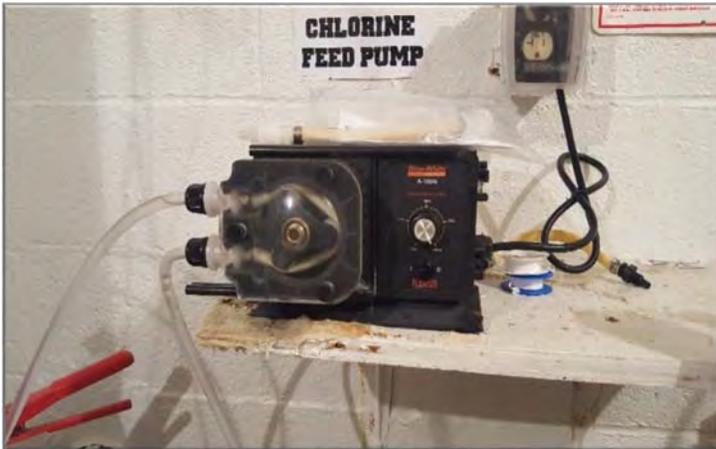
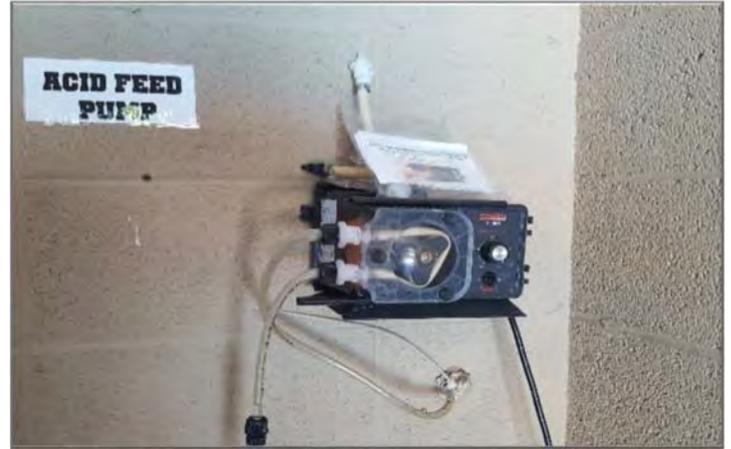
The chemical system is comprised of liquid chlorine and acid for adjusting the pH. Each chemical is injected in to the pool return pipe by metering pumps manufactured by Blue-White (see photos below).

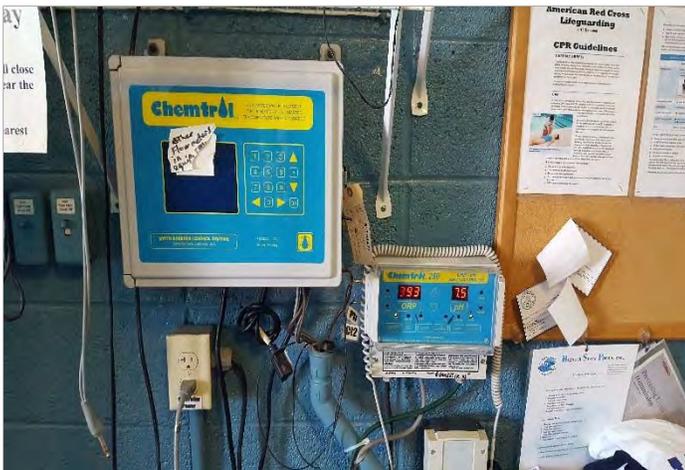
These pumps appear to be relatively new. The pool water chemistry is monitored by a Chemtrol model 250 chemical controller. This unit activates the chlorine and acid metering pumps as required to maintain proper chlorine and pH levels. The controller appears to be in good condition. The chlorine is stored in two 220-gallon polyethylene tanks that are located in the lower level of the bathhouse adjacent to the filters. These tanks are in good condition, but there is no containment system in the event of a leak. In addition, access to fill the chlorine tanks is inconvenient. (see photos below)

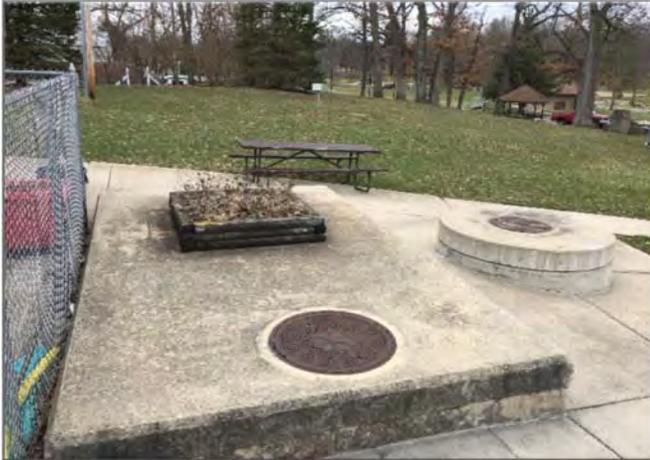
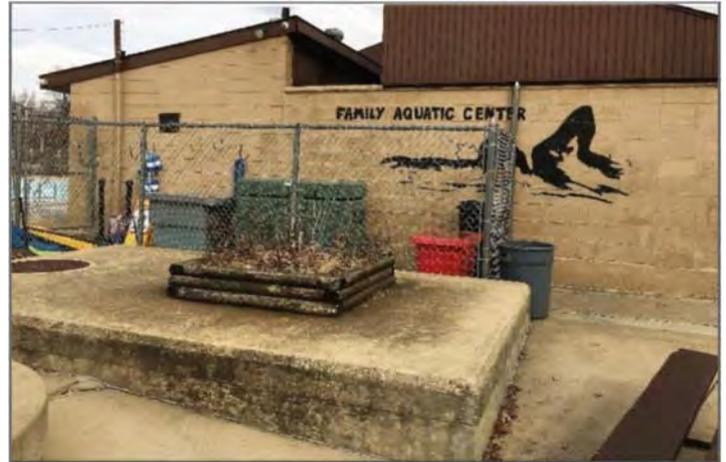
The original concrete surge tank is located on the west side of the bathhouse. A secondary surge tank was installed adjacent to the original when the zero-depth entry was constructed. This newer surge tank appears to collect water from the zero-depth entry gutters. There is a pipe that connects both surge tanks.

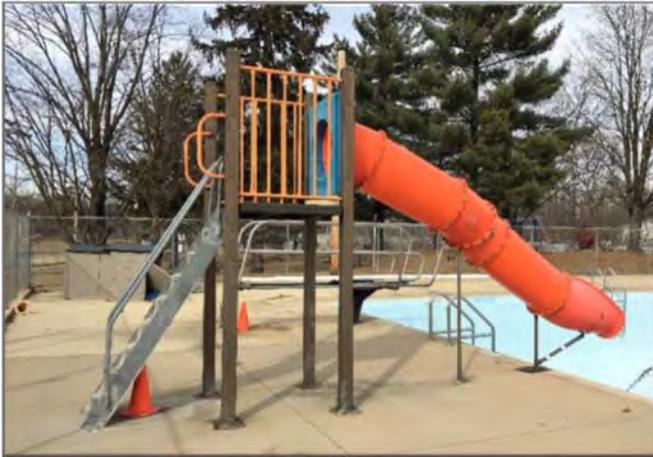
There is a small slide that exits into the deep end of the pool. The steel columns that support the slide platform exhibit extensive corrosion. At some point, consideration should be given to removing this slide.

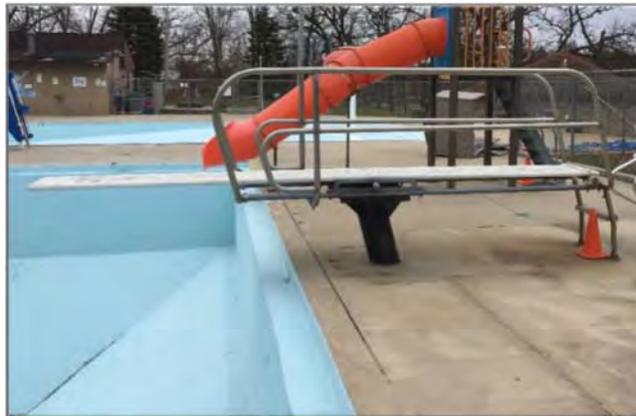
There is also a one-meter diving stand at the deep end of the pool. The diving stand is in fair condition, but the diving board is in extremely poor condition and should be replaced.

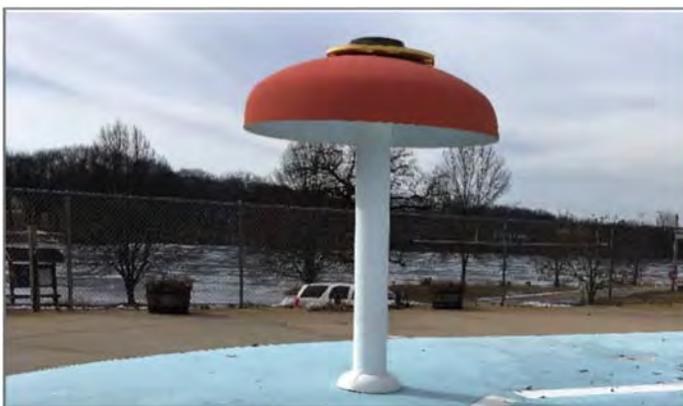
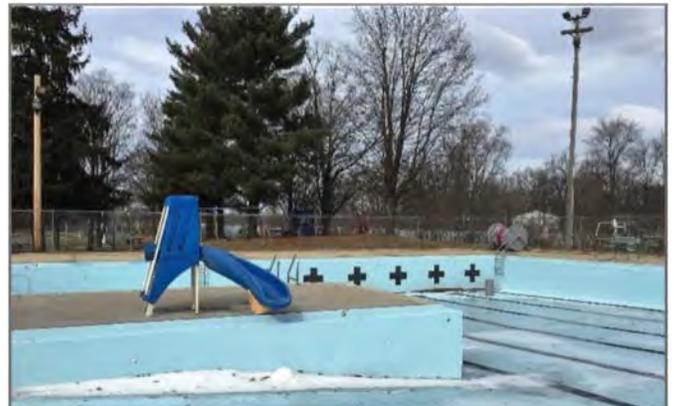
The zero-depth area has a small slide and a raindrop play feature. Both items of equipment are in good condition.

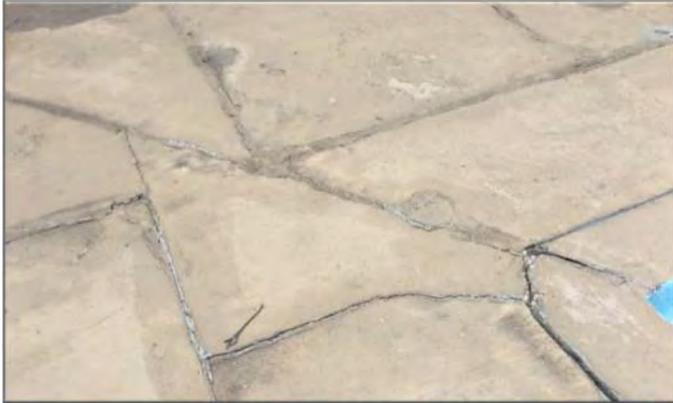
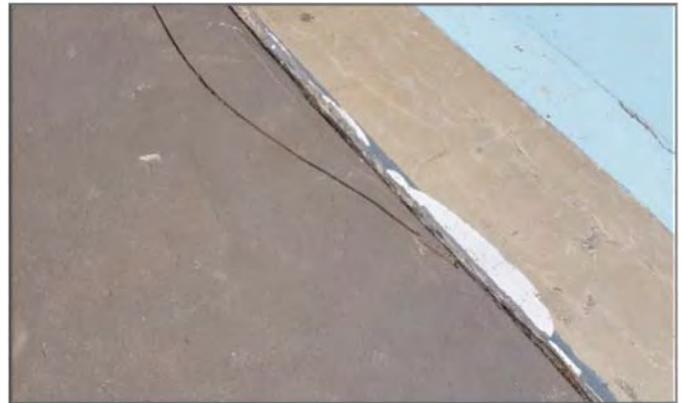
The older, original pool deck is in poor condition. There is settling showing evidence of possible water loss from the pool. Cracks from settlement have been caulked numerous times and are raised themselves, creating tripping hazards. There is also settlement between the pool deck and pool wall, causing a large gap in the joint. A pool grounding wire exposed in one location from this was observed. Some deck drains in these areas have been painted over and are partially blocked.

Full replacement of pool decks is recommended as the older decking area has met its useful life.

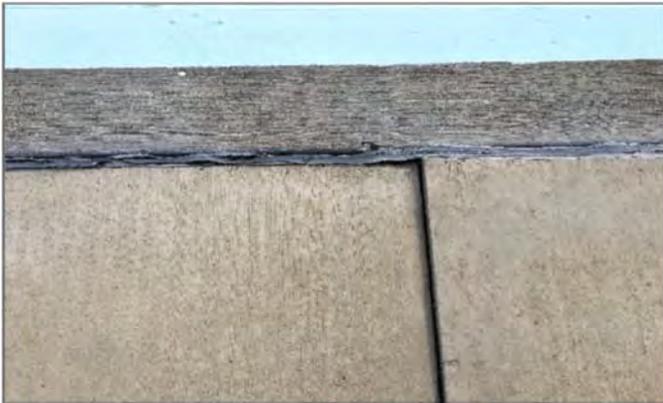
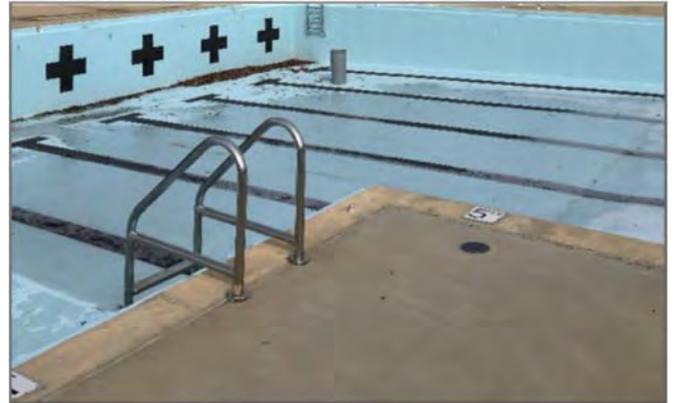
The newer pool deck addition is in fair condition with minor settlement and cracks.

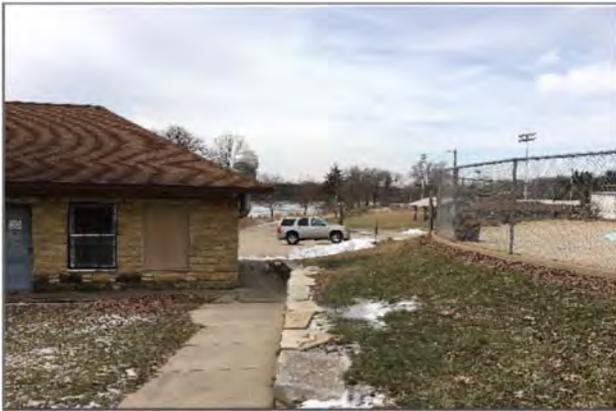
Walkways up to and surrounding the pool have settled enough to cause tripping hazards. The walkway up to admissions is in poor condition. The asphalt ramp to the sidewalk is deteriorated and uneven, there are major cracks in the concrete sidewalk, and the exhaust vent for the concessions kitchen is protruding into the path. This sidewalk does not meet ADA standards. Slope, handrails, and landings are the items that do not conform to current ADA codes.

It is recommended that all walkways be replaced and reworked for safer use and future development access.

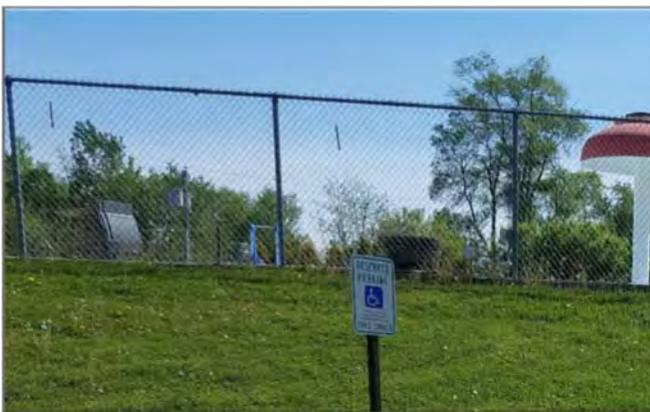
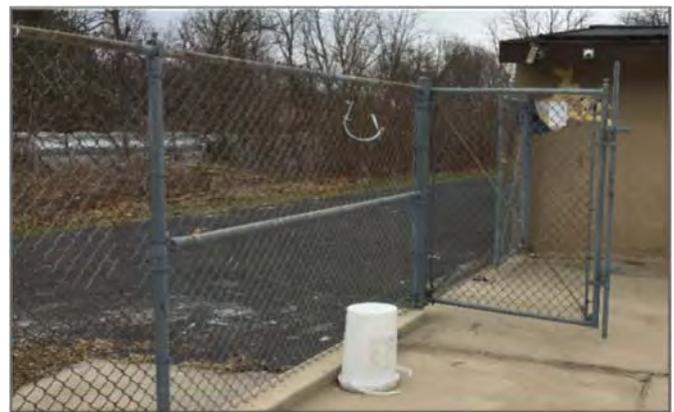
The existing galvanized chain-link perimeter fence is in fair condition with some rust and corrosion throughout.

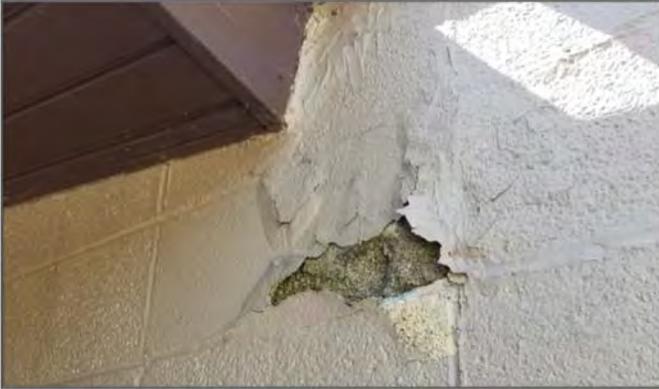
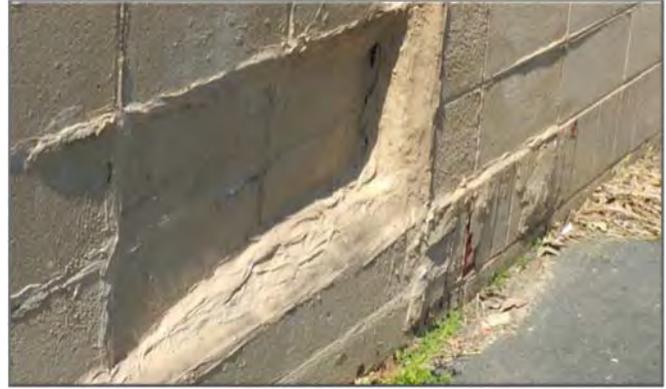
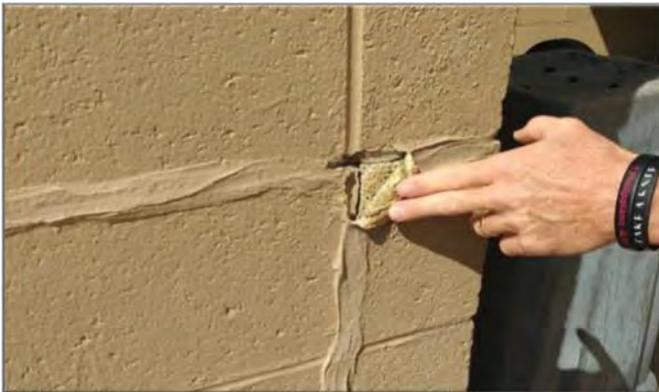
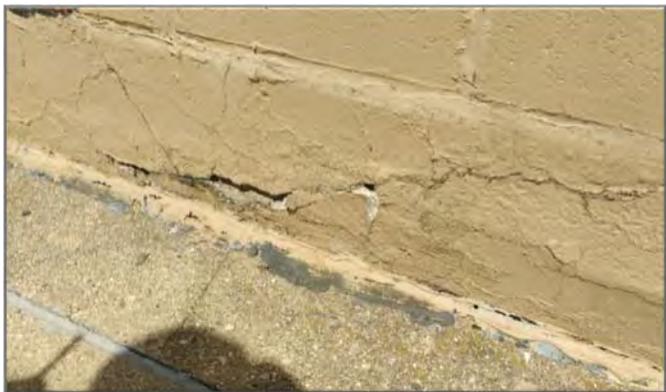
The concrete masonry unit (CMU) walls, particularly the exterior or those exposed to the elements, are in poor condition. CMU walls are deteriorating, paint is peeling, and an excessive number of joints have been filled with caulk to remedy water damage in the walls. CMU walls appear to be hollow and improperly reinforced structurally. Damage to the East exterior wall has occurred and may indicate little to no reinforcement within the wall. Exterior block walls do not appear to be flashed properly and are without weep holes and drip edges.

It is recommended that the bathhouse building be replaced and relocated. It has met its useful life and would require extensive repairs that would be costly and inefficient towards any future development. A separate filter building is recommended, as the present filter room does not provide adequate space or meet current code.

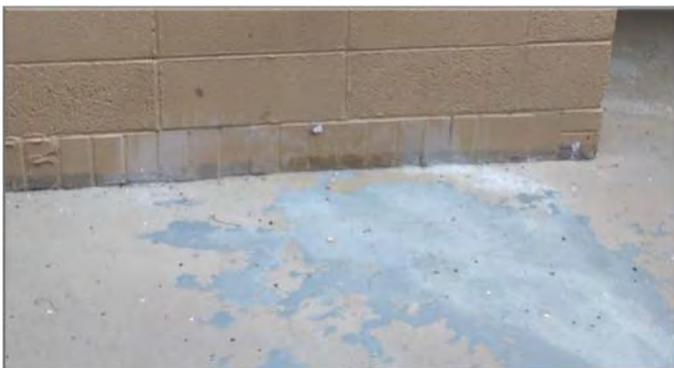
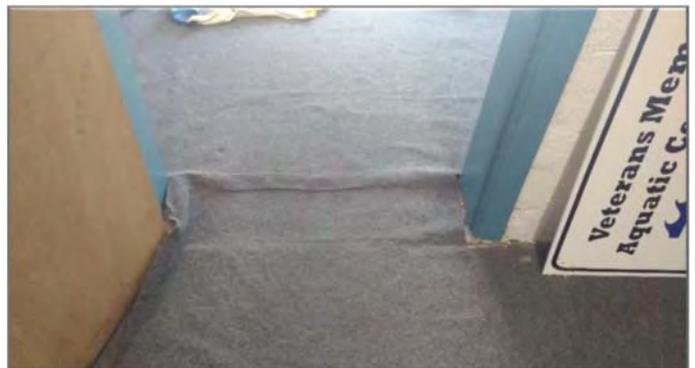
Concrete floors are spalling and settling. Filling of flooring voids is failing and creating tripping hazards. Settling is creating tripping hazards throughout, particularly at various building entrances. Carpet in manager's office and admissions is in poor condition and improperly installed, creating multiple tripping hazards.

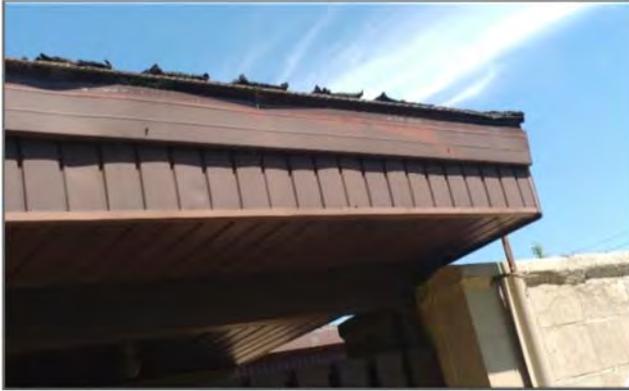
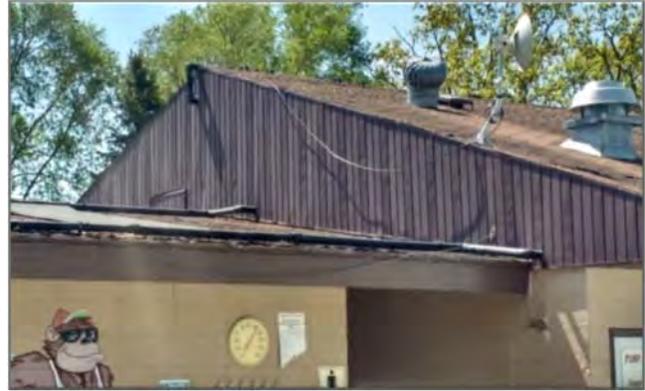
Asphalt shingles are in poor condition. Shingles are past their useful life and are curling and popping up in many locations.

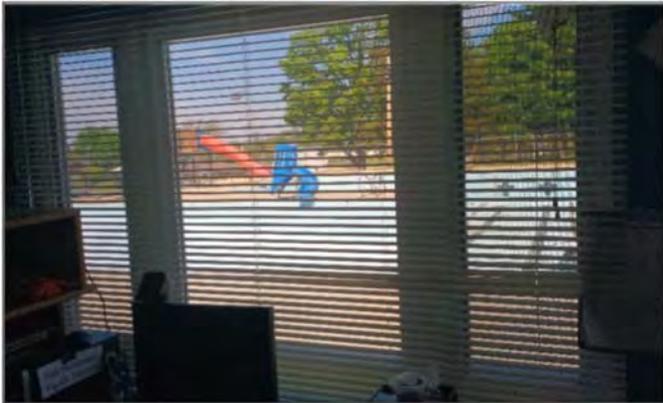
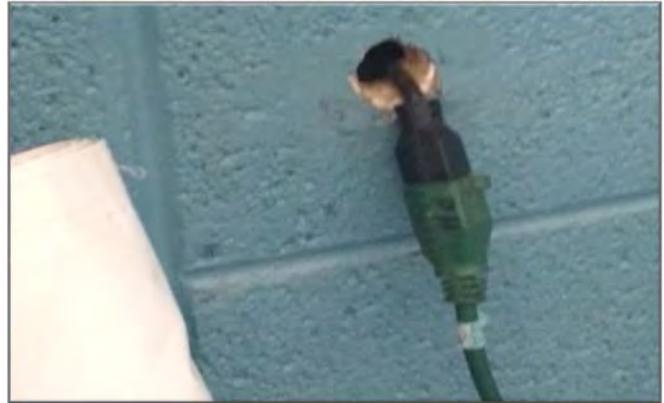
Walls and ceiling are in fair condition. Space layout is inadequate. Manager cannot see entire pool from office. First-Aid room is lacking hand sink and adequate treatment area.

An extension cord run through office wall into chemical storage room to supply power for a pump does not meet current electrical code.

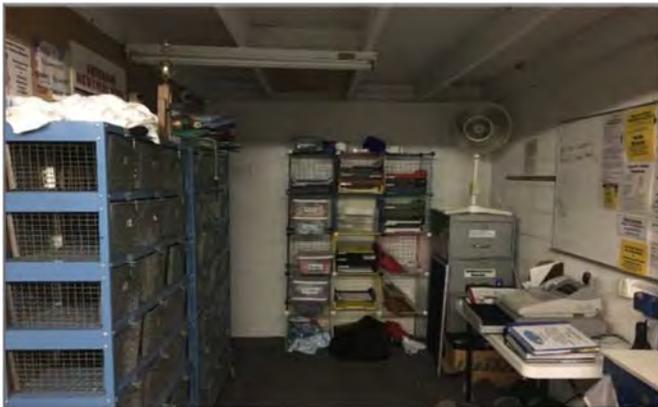
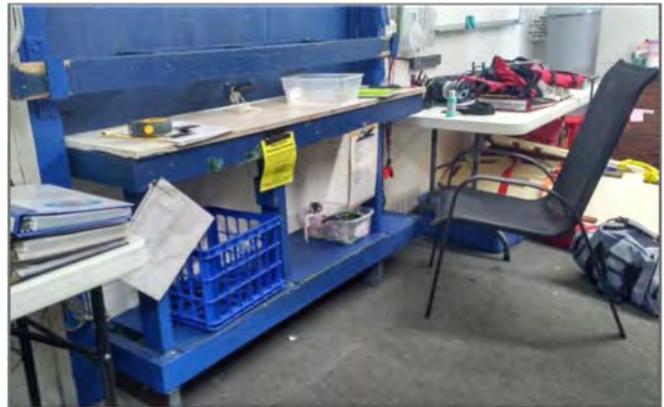
Office and closet walls and ceilings are in fair condition. Storage space is inadequate to meet current needs. Patrons' personal storage baskets are outdated and take up space in office area.

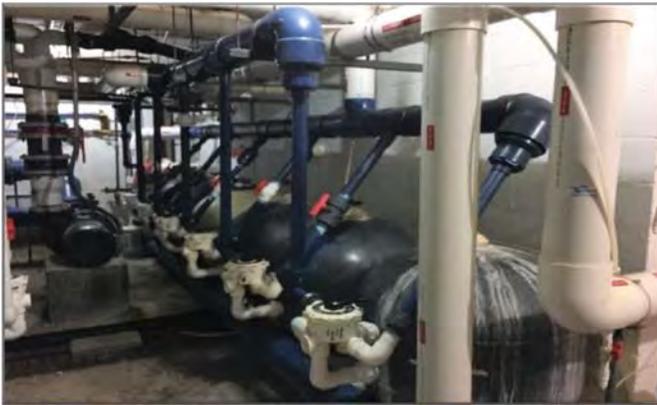
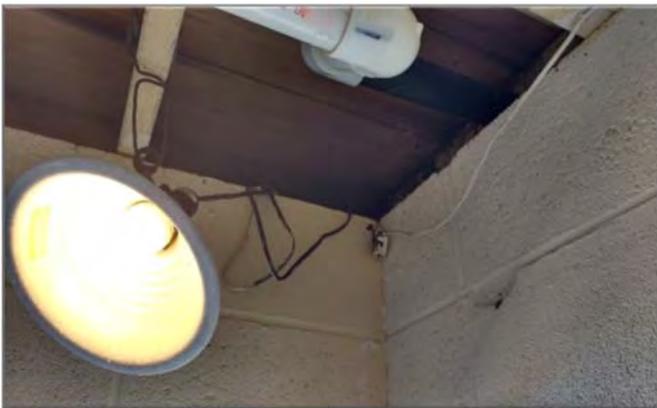
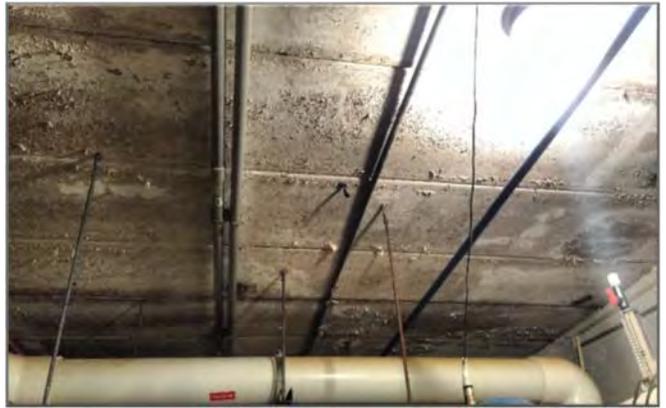
Walls, ceiling, and door are in poor condition. Improper ventilation is adding to the highly corrosive environment. Lighting is inadequate.

Walls, ceiling, and floor are in poor condition. There is no ventilation present in the pool equipment room. This condition is a potential hazard, and also appears to be damaging the equipment and building.

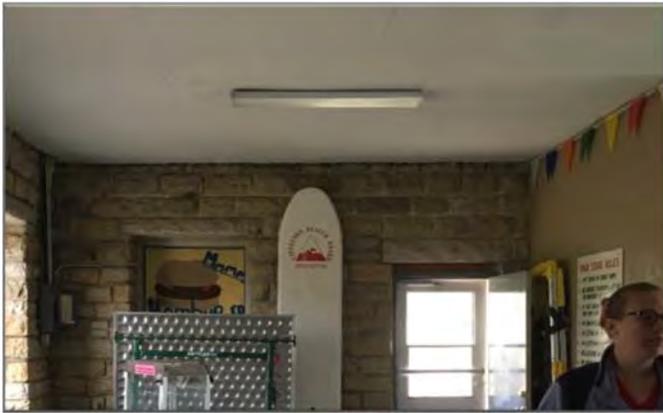
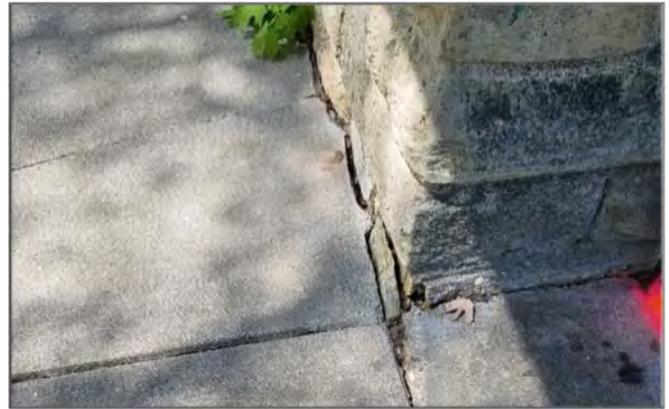
Original limestone walls appear to be in good condition with very little deficiencies. Original mortar joints are intact with only minor areas in need of patching.

Floor slab is in fair condition. Ceiling is cracking and appears to be in poor condition. There is no insulation above ceiling.

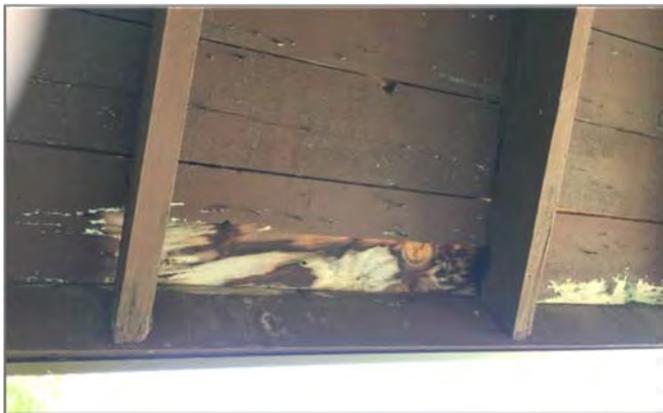
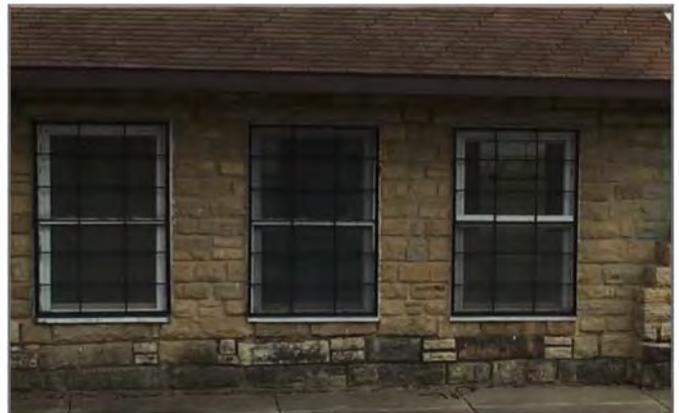
Asphalt shingles are in poor condition. Metal fascia is dented and inadequately attached in certain locations. There is evidence of rotten roof deck at various locations.

Wood window frames are rotting, and windows are not properly sealed from the exterior. One window has broken glass.

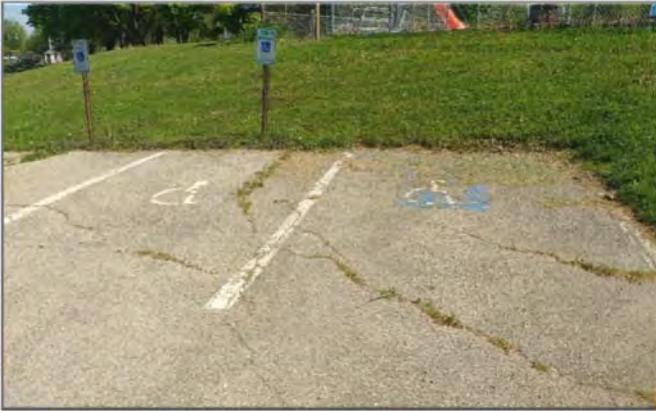
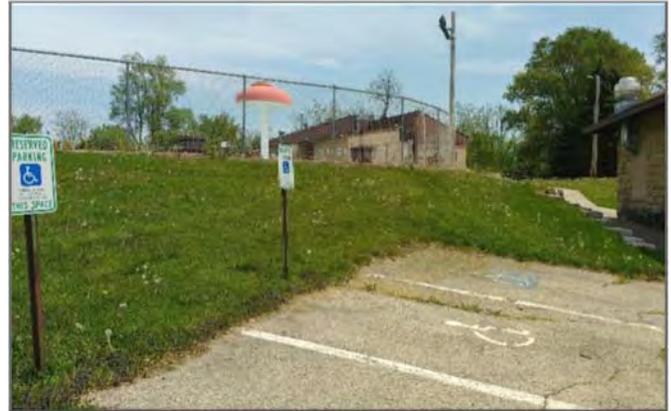
The approach to the Veteran's Memorial Aquatic Center is unfavorable as there is no designated vehicular drop-off route and no landscape to beautify or break up the asphalt surrounding the front of the building. Asphalt is in poor condition with deterioration.

It is recommended that the parking lot be redesigned to accommodate more parking stalls, a drop-off route, current code compliant accessible parking, and landscape islands to soften expanse of asphalt and complement the historic Park Store building and allow for safe pedestrian movement.

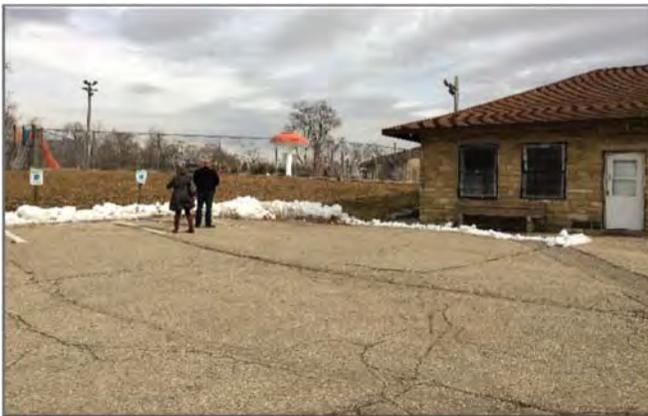
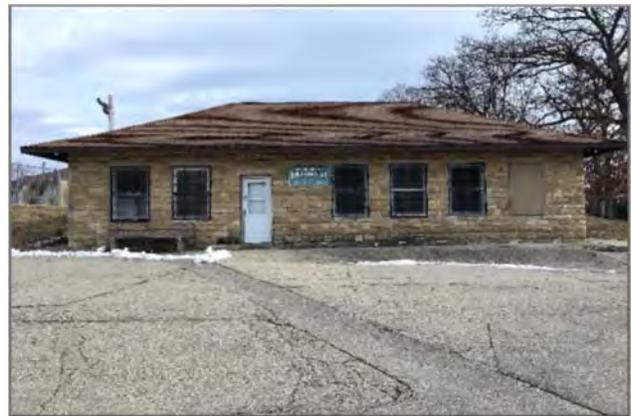
There are (3) parking spaces marked as accessible spaces; only one is required for this size of a parking lot. However, it would need to be van-accessible. The existing spaces do not comply in several ways: the ground surface slopes are too great, there is not an accessible aisle to the sides of the spaces, and the signage is not mounted at the correct height.

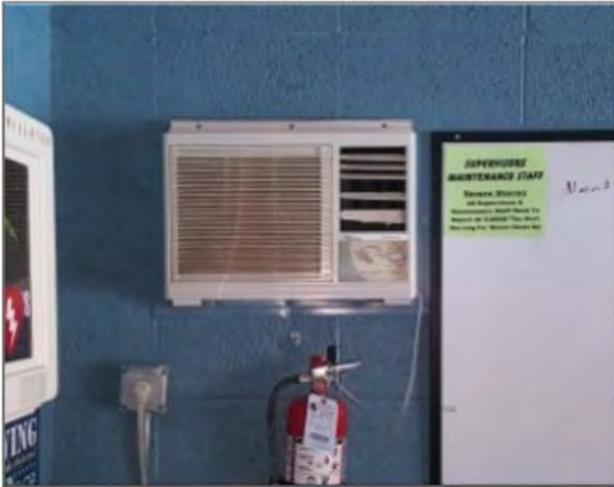
The Bathhouse is open to the exterior and there is no HVAC present. The pool office contains an 'Amana' thru-wall A/C unit. There is no HVAC present in the Park Store/Concessions Building except for an exhaust hood. Exhaust for the hood runs out the wall and up through the roof to a roof-mounted exhaust fan. The exhaust hood and fan appeared to be in good condition. The thru-wall A/C unit appeared to be in fair condition.

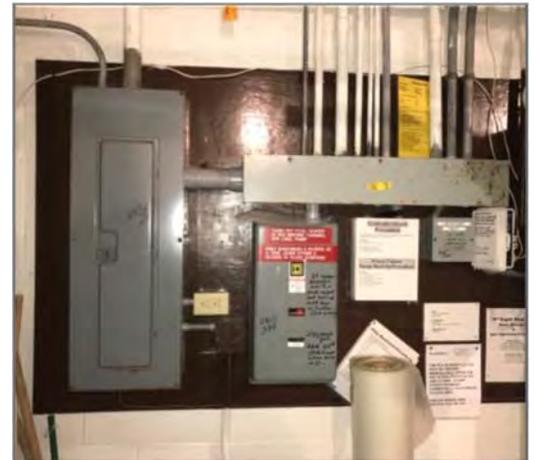
Main Panel in Basement Equipment Room

The electrical system is in fair to poor condition. The electrical panel in the basement filter building appears to have rust and corrosion due to exposure to pool chemicals utilized in the same room. Electrical panel interior components are subjected to the same corrosion. Conduits within the basement Filter Building were observed to have surface corrosion. The existing 200-amp, 120/240V, 3 phase service is insufficient for building remodeling and/or expansion.

It is recommended that the existing exterior meter be replaced with main disconnect; existing pool deck receptacles be changed to GFCI type with weather-proof "while-in-use" covers; existing 25-HP filter pump, chlorine pump, and solar pump be bonded; install chlorine feed pump on GFCI protected circuit; and replace the basement electrical panel and existing corroded conduits in that room.

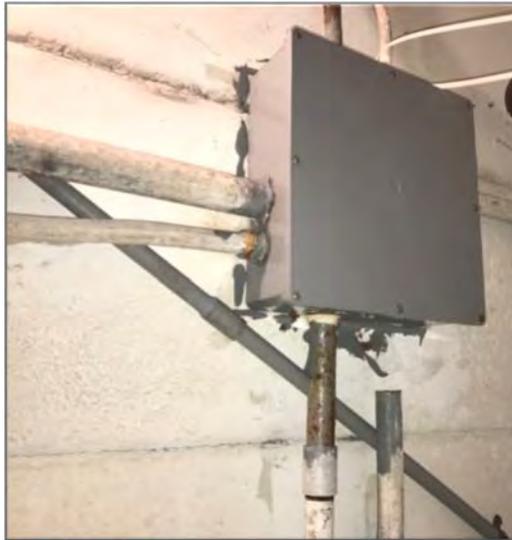
Conduits in Equipment Room Corroded

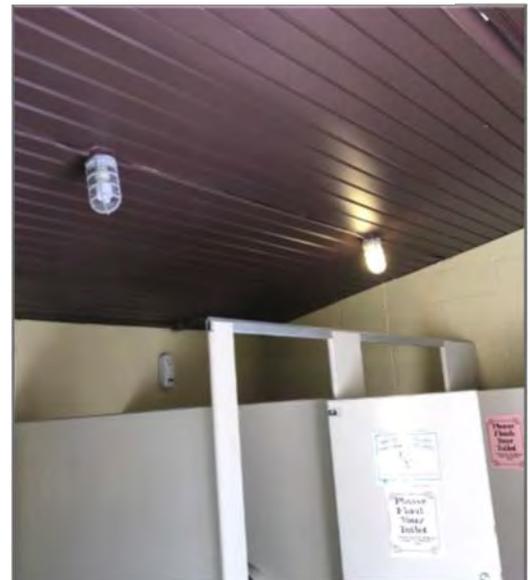
Washroom Jelly-Jar Lights

The interior lighting is in poor condition and inefficient compared to today's standards and current energy codes. The majority of lighting within the facility is fluorescent type with T8 linear bulbs and compact fluorescent lamps (CFL). Lighting controls within the facility are manual type. Lighting within changing areas are jelly-jar type with compact fluorescent bulbs. Lighting levels appear insufficient.

- Upgrade existing interior lighting fixtures to LED.
- Upgrade existing exterior building lighting fixtures to LED.
- Install occupant sensors in all private offices, washrooms, open offices, storage rooms, etc.; lighting will automatically de-energize when not occupied. Required per current IECC 2015 energy codes.
- Common areas such as stairwells and hallways may be controlled via time-clock control device and de-energizing lighting at predetermined times, compliant with current IECC 2015 energy code.
- Install LED Exit sign and emergency battery lights.
- Replace existing Pool deck lighting with LED-type lighting fixtures.

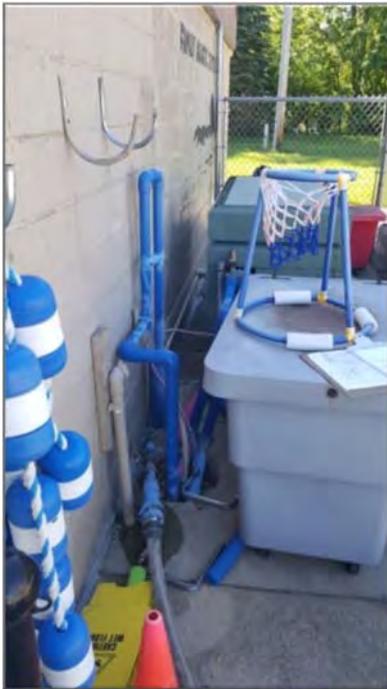
Manual pool fill & hose

- The drinking fountains are not ADA compliant.
- The hose connections on the building façade do not have backflow protection.
- The structure receiving pool deck drainage may be a sanitary structure. If it is a sanitary structure, the deck drainage needs to be routed to a lift station and drained to the sanitary system indirectly (with an air gap). Direct connections to the sanitary system are not recommended, as it allows the potential for sanitary waste water to back up onto the pool deck or pool equipment room.
- The 1-1/2" manual pool fill does not have backflow protection.

- Replace drinking fountains with ADA-compliant models.
- Add vacuum breakers to the hose connections on the building façade.
- Verify if the structure receiving deck drainage is a sanitary storm structure. If sanitary, provide a lift station.
- Add 1-1/2" RPZ for manual pool fill.
