Existing Conditions Report & Pool Study

Veteran's Memorial Aquatic Center | 360 Burr W Jones Circle, Evansville, Wisconsin 53536

City of Evansville

12 September 2017

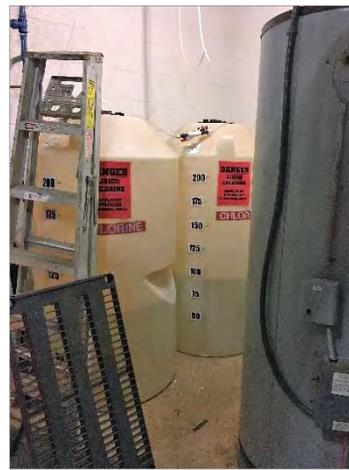
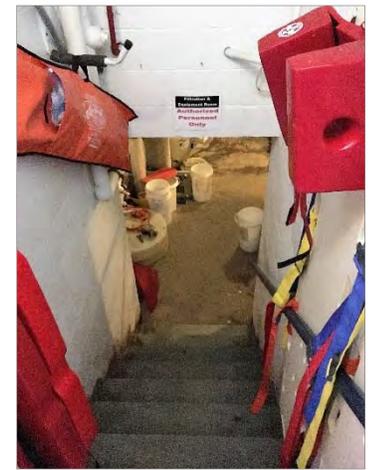
These pumps appear to be relatively new. The pool water chemistry is monitored by a Chemtrol model 250 chemical controller. This unit activates the chlorine and acid metering pumps as required to maintain proper chlorine and pH levels. The controller appears to be in good condition. The chlorine is stored in two 220-gallon polyethylene tanks that are located in the lower level of the bathhouse adjacent to the filters. These tanks are in good condition, but there is no containment system in the event of a leak. In addition, access to fill the chlorine tanks is inconvenient. (see photos below)

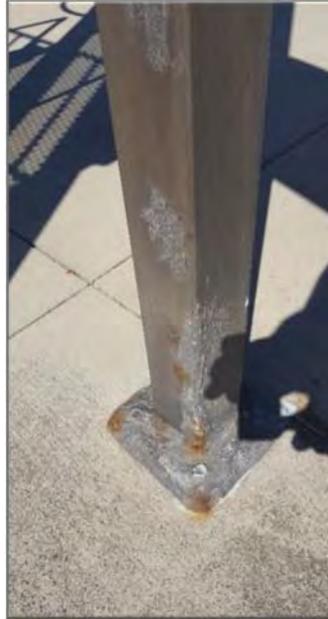
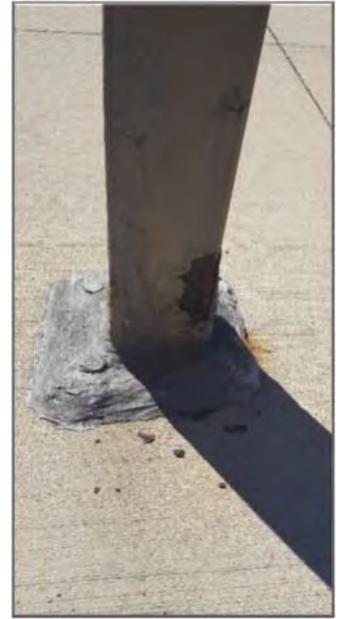
There is a small slide that exits into the deep end of the pool. The steel columns that support the slide platform exhibit extensive corrosion. At some point, consideration should be given to removing this slide.

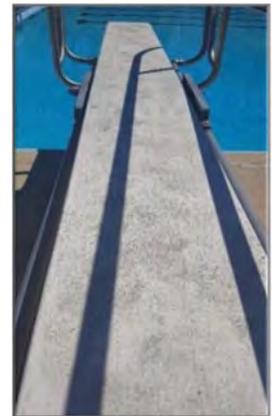
There is also a one-meter diving stand at the deep end of the pool. The diving stand is in fair condition, but the diving board is in extremely poor condition and should be replaced.

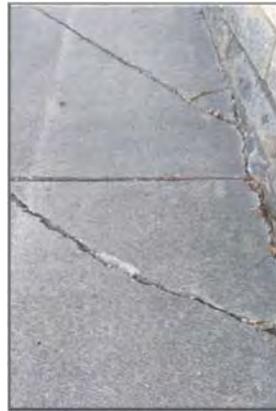
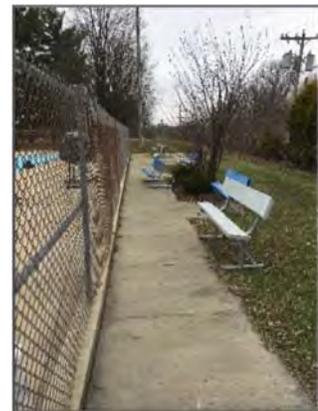
Walkways up to and surrounding the pool have settled enough to cause tripping hazards. The walkway up to admissions is in poor condition. The asphalt ramp to the sidewalk is deteriorated and uneven, there are major cracks in the concrete sidewalk, and the exhaust vent for the concessions kitchen is protruding into the path. This sidewalk does not meet ADA standards. Slope, handrails, and landings are the items that do not conform to current ADA codes.

It is recommended that all walkways be replaced and reworked for safer use and future development access.

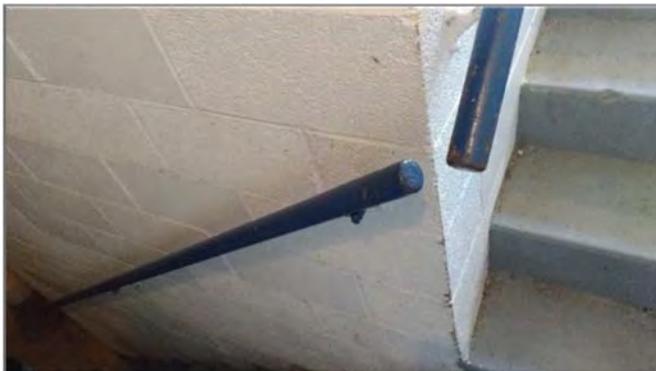
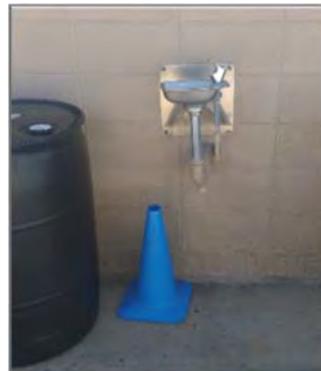
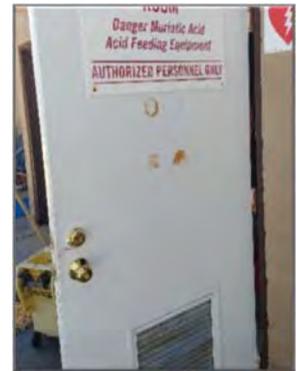
- There are no ADA-compliant signs at the entrances.
- Showers are sharing floor drains. Code requires individual drains for each shower.
- There is not a floor drain in the toilet area.

- PVC supply piping does not meet current code.

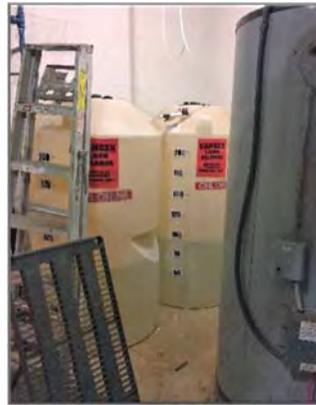
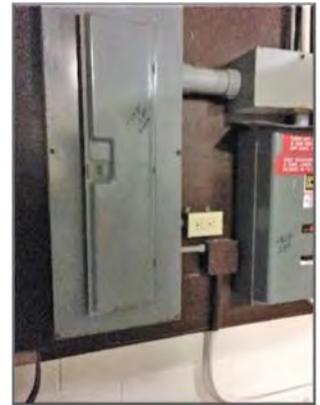
Walls, ceiling, and floor are in poor condition. There is no ventilation present in the pool equipment room. This condition is a potential hazard, and also appears to be damaging the equipment and building.

It is recommended that the bathhouse building be replaced and relocated. It has met its useful life and would require extensive repairs that would be costly and inefficient towards any future development. A separate filter building is recommended, as the present filter room does not provide adequate space or meet current code.

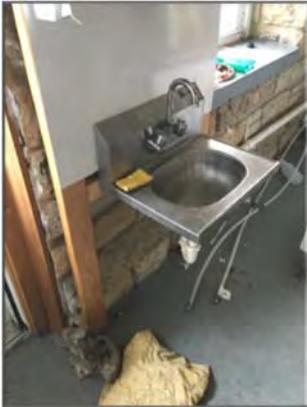
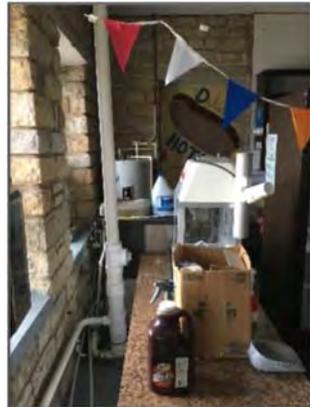
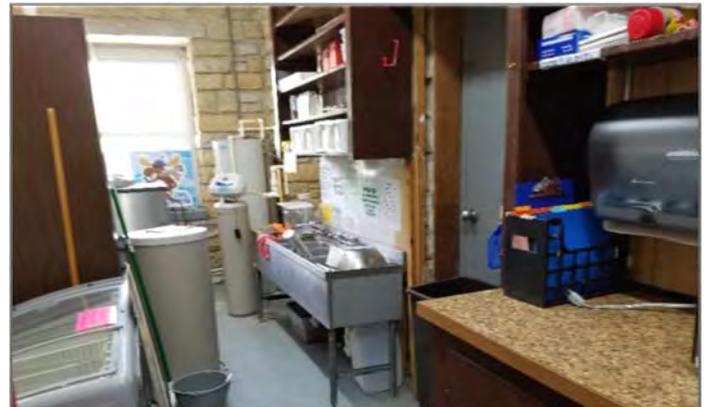
Kitchen layout is inefficient. Although storage space is ample, kitchen space is crowded and poorly arranged. The hand sink is located directly next to the main entry and should be in the back of the space near any food-prep area.

The Park Store building is currently under-utilized, but it is in good condition. It has the potential to be a beautiful, well-functioning, and greater utilized space by renovating the space layout and correcting current code issues.

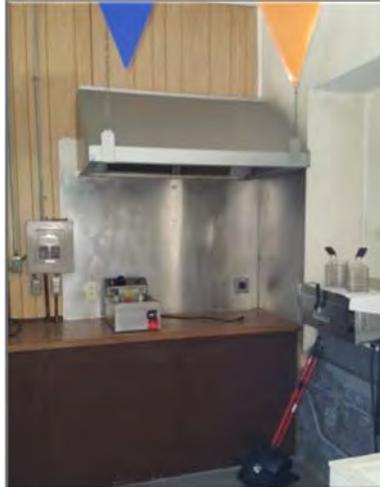
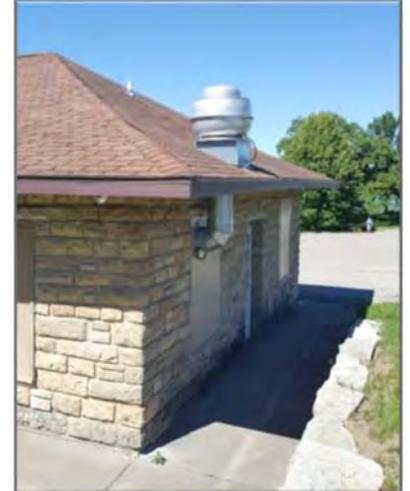
The Bathhouse is open to the exterior and there is no HVAC present. The pool office contains an 'Amana' thru-wall A/C unit. There is no HVAC present in the Park Store/Concessions Building except for an exhaust hood. Exhaust for the hood runs out the wall and up through the roof to a roof-mounted exhaust fan. The exhaust hood and fan appeared to be in good condition. The thru-wall A/C unit appeared to be in fair condition.

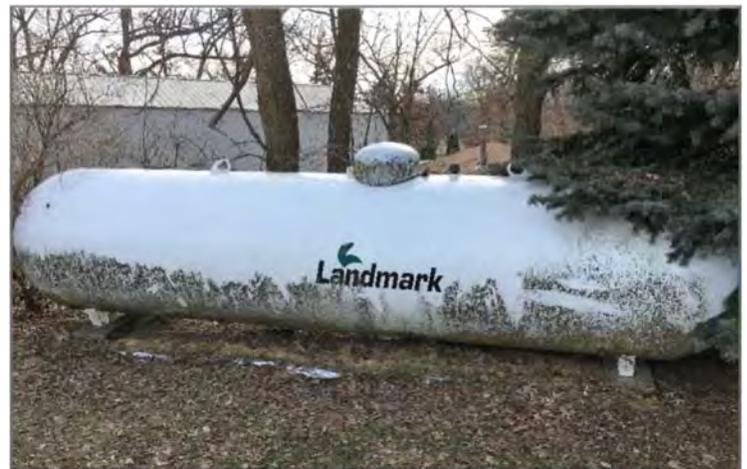
The pool water is heated by a "Raypak" hot water heater (model # P-1083). The unit is installed outdoors, and has a gas input rating of 1,035,000 BTU's. This unit operates on propane fuel provided by an on-site propane tank.

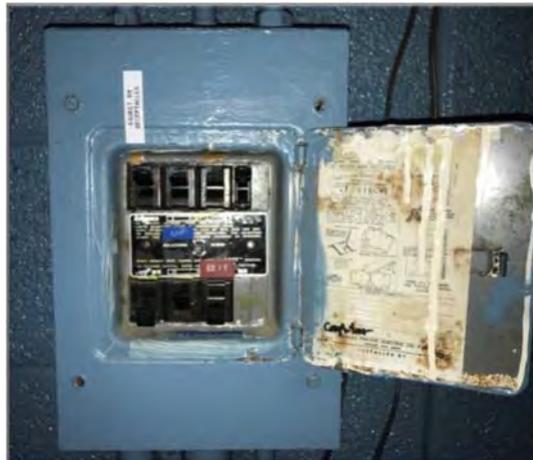
Main Panel in Basement Equipment Room

The electrical system is in fair to poor condition. The electrical panel in the basement filter building appears to have rust and corrosion due to exposure to pool chemicals utilized in the same room. Electrical panel interior components are subjected to the same corrosion. Conduits within the basement Filter Building were observed to have surface corrosion. The existing 200-amp, 120/240V, 3 phase service is insufficient for building remodeling and/or expansion.

It is recommended that the existing exterior meter be replaced with main disconnect; existing pool deck receptacles be changed to GFCI type with weather-proof "while-in-use" covers; existing 25-HP filter pump, chlorine pump, and solar pump be bonded; install chlorine feed pump on GFCI protected circuit; and replace the basement electrical panel and existing corroded conduits in that room.

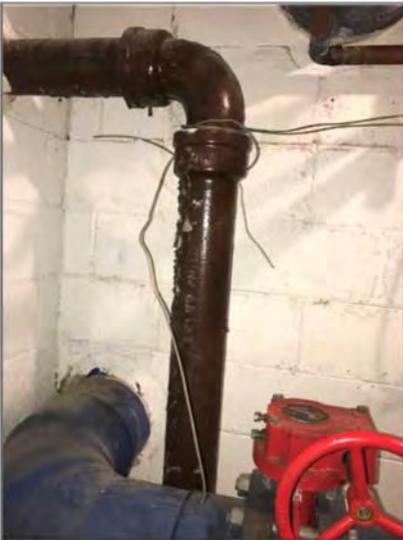
Bonding Conductor not connected

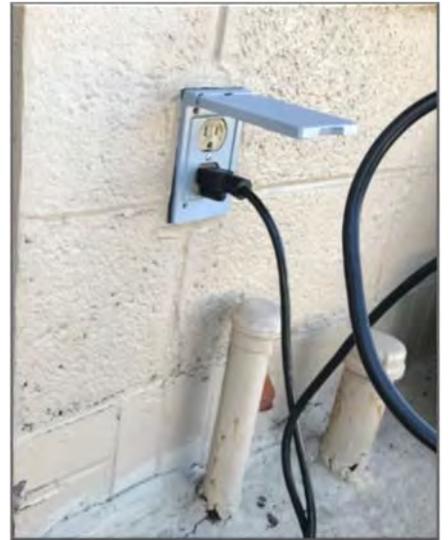
Non-GFCI Protected Exterior Outlet

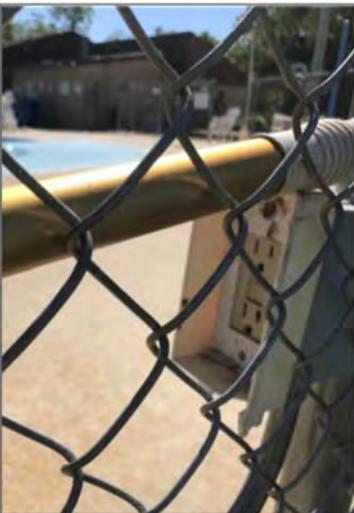
Pool Deck Outlet – No Cover

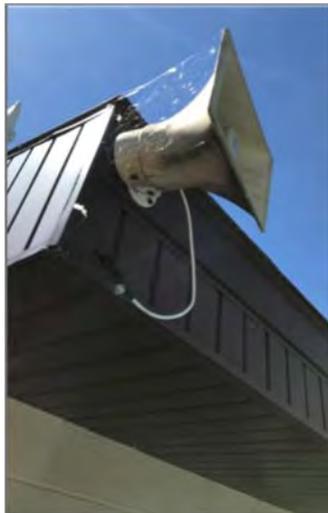
Public-Address Speaker

Multiple PA (Public Address) speakers were observed on pool deck. The speakers appear antiquated.

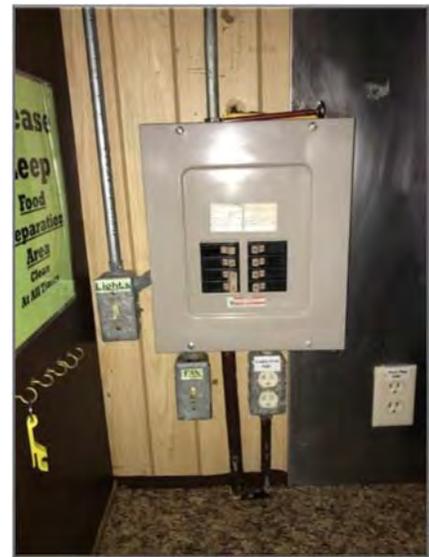
Panel Near Kitchen

The electrical system appears to be in fair condition. The electrical panel appears to be at its maximum capacity. The electrical panel and service size would need to be upgraded to a larger service, if building occupancy type expands.

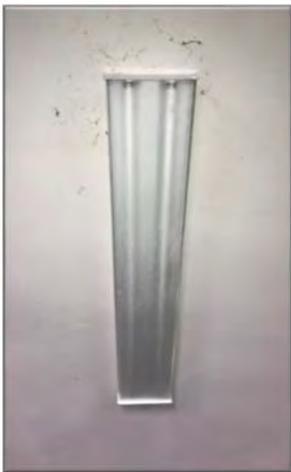
Interior lighting is in average condition and energy inefficient compared to today's standards and current energy codes. A majority of the lighting within the facility are 8'-0" & 4'-0" fluorescent strip (no lens) and wraparound (w/ lens) with T8 linear bulbs. Four (4) ceiling fans present in the open dining area are in operable condition and controlled via toggle switch near the electrical panel. Interior lighting controls within the facility are manual type.

8'-0" Strip fixture
(No Lens)

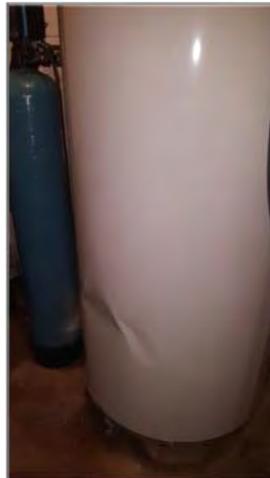
A water softener provides softened water to the showers and is in good condition. The hot water system consists of a 100-gallon propane water heater. The water heater, located in the basement, has an input of 199,999 BTU/hour. The water heater is less than one year old and is in good condition with minor damage (dents) on the backside of the heater. A thermostatic mixing valve provides tempered water to the locker-room showers.

Water heater damage

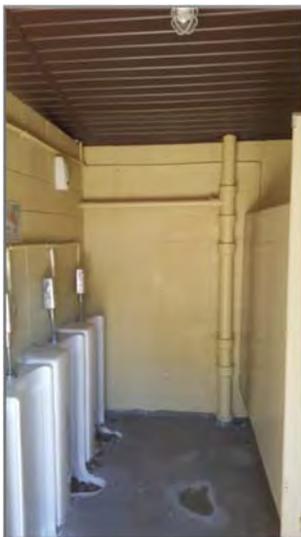
Metering Showers

- The lavatories need a single-tempered water supply or hot and cold supplies. Currently, only cold water serves the lavatories.
- The shower stalls need one floor drain per showerhead. Currently, two floor drains serve six showers.
- A hose connection is not present.
- A floor drain is not present in the locker room. The stall type urinal currently functions as a floor drain.
- Although much of the waste and vent piping is concealed, it does not appear that an adequate number of vents are present. Typically, each fixture has individual vents.
- Sections of PEX piping are exposed to sunlight, which is contrary to the manufacturer’s recommendations.

- Given the issues with drain quantity and venting, it is recommended that the majority of the waste and vent system serving the locker room be replaced.
- Provide hot or tempered water to the lavatories.

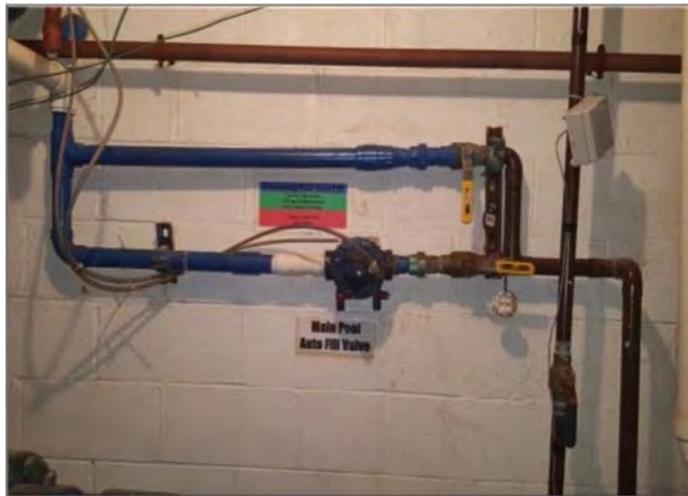
Pool fill termination (exterior)

Air gap not present on automatic pool fill.

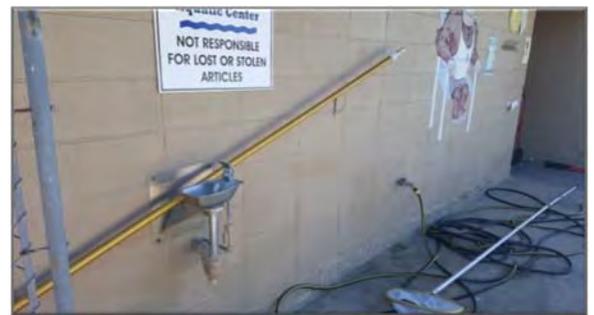
Drinking fountain and hose connection

- The drinking fountains are not ADA compliant.
- The hose connections on the building façade do not have backflow protection.
- The structure receiving pool deck drainage may be a sanitary structure. If it is a sanitary structure, the deck drainage needs to be routed to a lift station and drained to the sanitary system indirectly (with an air gap). Direct connections to the sanitary system are not recommended, as it allows the potential for sanitary waste water to back up onto the pool deck or pool equipment room.
- The 1-1/2" manual pool fill does not have backflow protection.

- Replace drinking fountains with ADA-compliant models.
- Add vacuum breakers to the hose connections on the building façade.
- Verify if the structure receiving deck drainage is a sanitary storm structure. If sanitary, provide a lift station.
- Add 1-1/2" RPZ for manual pool fill.
